Stonbury was contracted to make repairs to several column supports for the distribution system surrounding a filter bed at a wastewater treatment site.

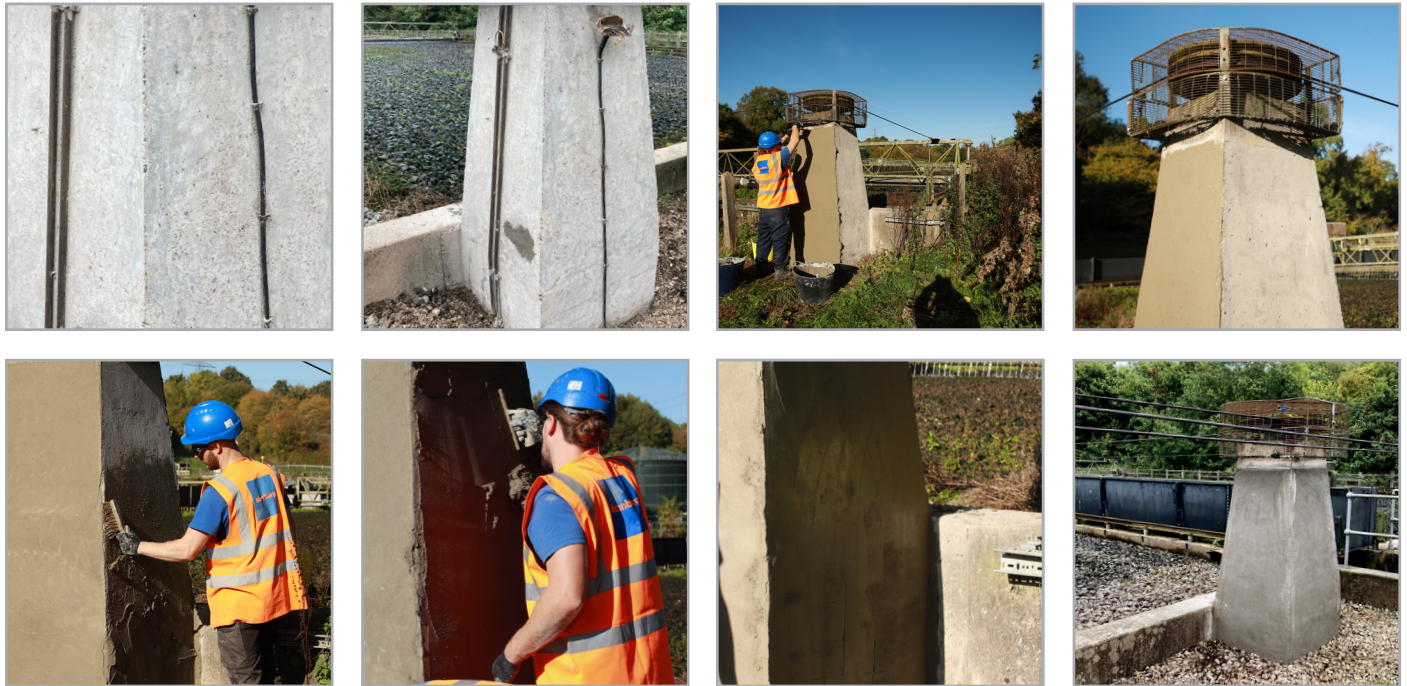
A routine inspection highlighted cracks in fourteen distributor support columns around a large gravel trickling filter at a wastewater treatment site.

Stonbury was contacted to mobilise to site and repair the damaged render to stop water ingress and protect the integrity of the internal steel supports.

Once the electric to the pulley system was isolated, preparatory work to clear vegetation from around the columns was completed, before cleaning the columns using high-pressure water jetting (HPWJ).

The team then used a cup grinder to roughen the entire existing surface before fully coating the columns in an environmentally friendly, fast-set cementitious render.
