After a service reservoir was scoped by an external structural engineer and found to show signs of water ingress, Stonbury was contracted to identify and install a solution.

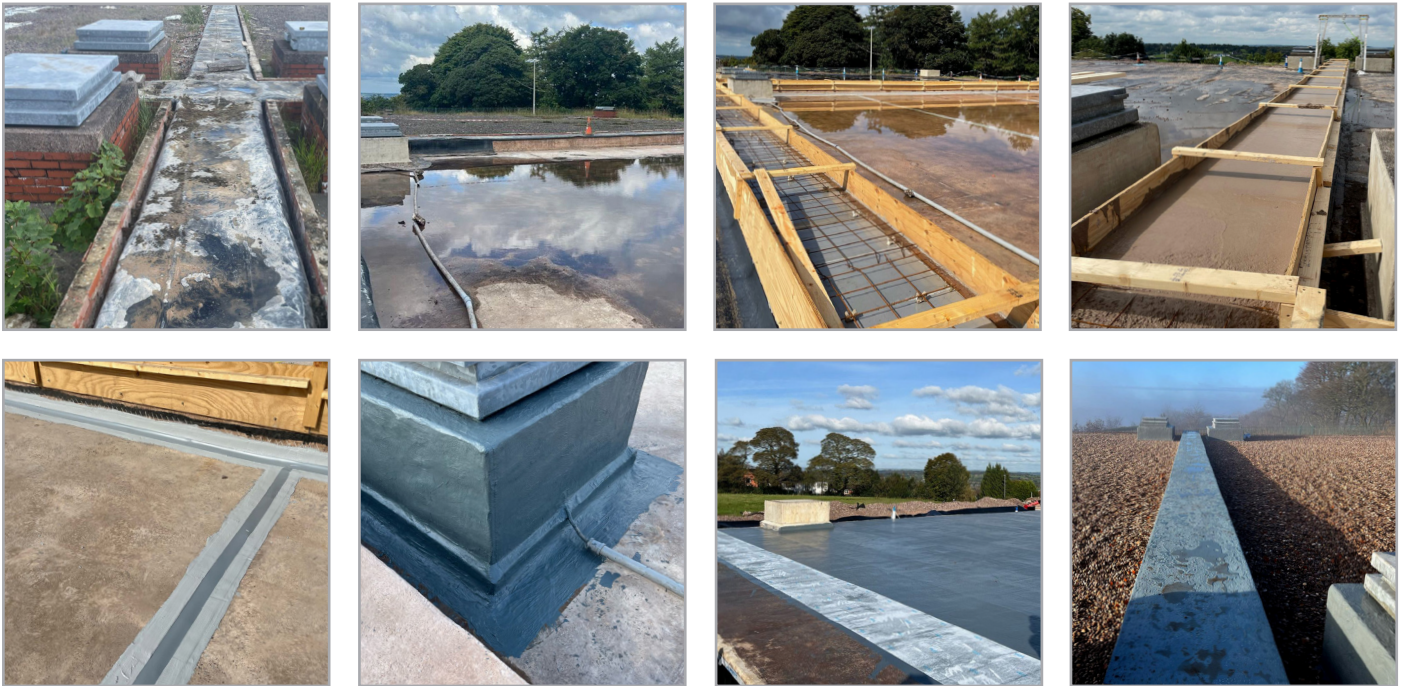
When Stonbury removed the roof overburden, the team identified severe ponding across all four tanks which was not captured in the initial report. In addition, drain voids between the cells were covered only by loose slabs, posing a severe health and safety risk to operatives.

The liquid membrane was the favourable option, as in addition to the cost savings, it worked in conjunction with the plans to remove the loose slabs over the drain voids and replace them with new stainless steel slabs and a concrete cast pathway, allowing the membrane to be installed as a continuous system across all four cells.

Before installing the solution, the team completed roof repairs, overbanding, render application and the new walkways. Following successful patch and pull-off tests for the liquid membrane, the water-tight system was installed across the roof of all four cells. Minor concrete repairs and pipework removal was conducted internally.
